**EMERGENCY STRUCTURAL ASSESSMENT
OF
EARTHQUAKE DAMAGE TO KAILUA - KONA WHARF
LOCATED AT
KAILUA - KONA, HAWAII

PREPARED FOR
THE STATE OF HAWAII
DEPARTMENT OF LAND AND NATURAL RESOURCES
DIVISION OF BOATING AND OCEAN RECREATION
HONOLULU, HAWAII 96813**

**ARNOLD T. OKUBO & ASSOCIATES, INC.
94-529 UKEE STREET, SUITE 107
WAIPAHU, HAWAII 96797**

NOVEMBER 2006

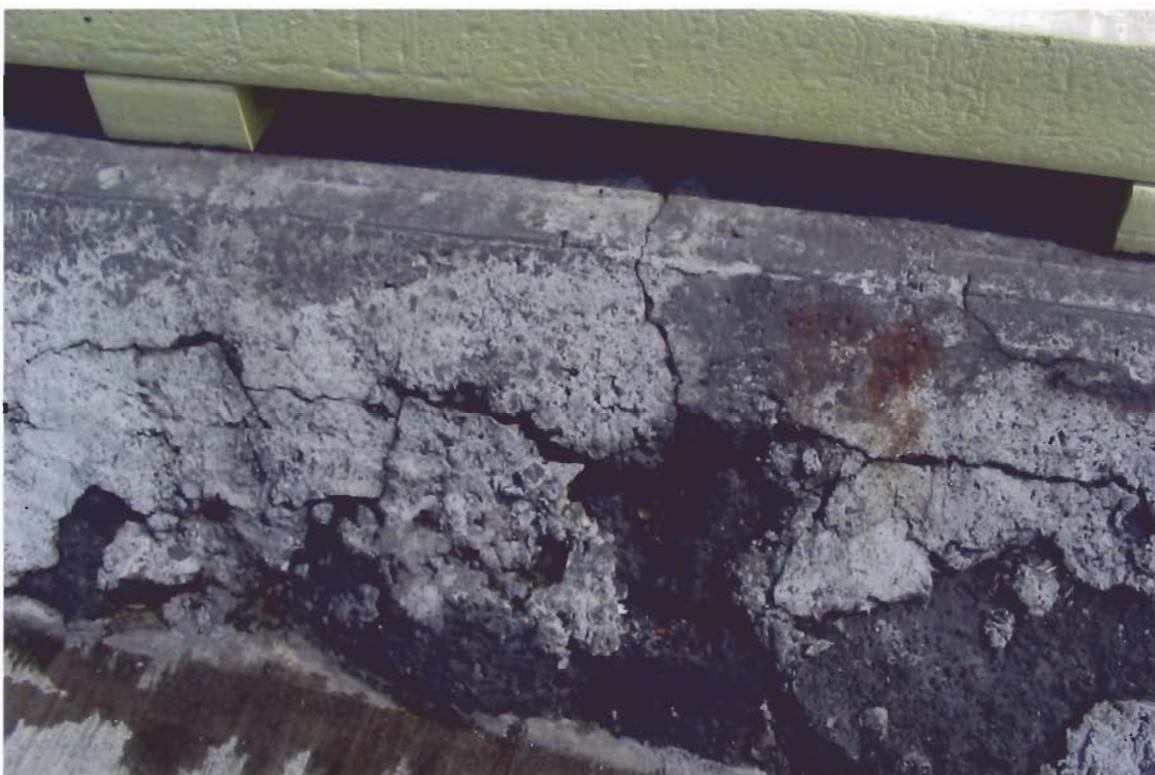
63

Crack CRM walls throughout
along Loading Dock No. 4

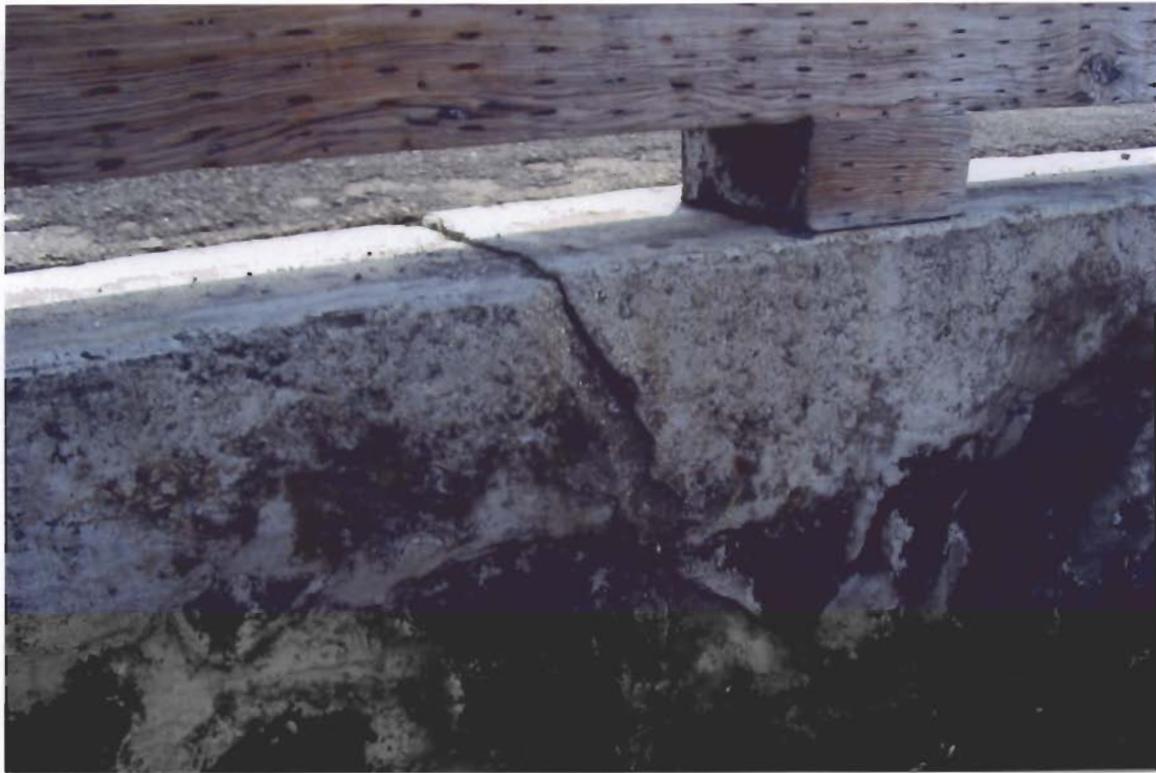
64

Crack CRM walls throughout
along Loading Dock No. 4

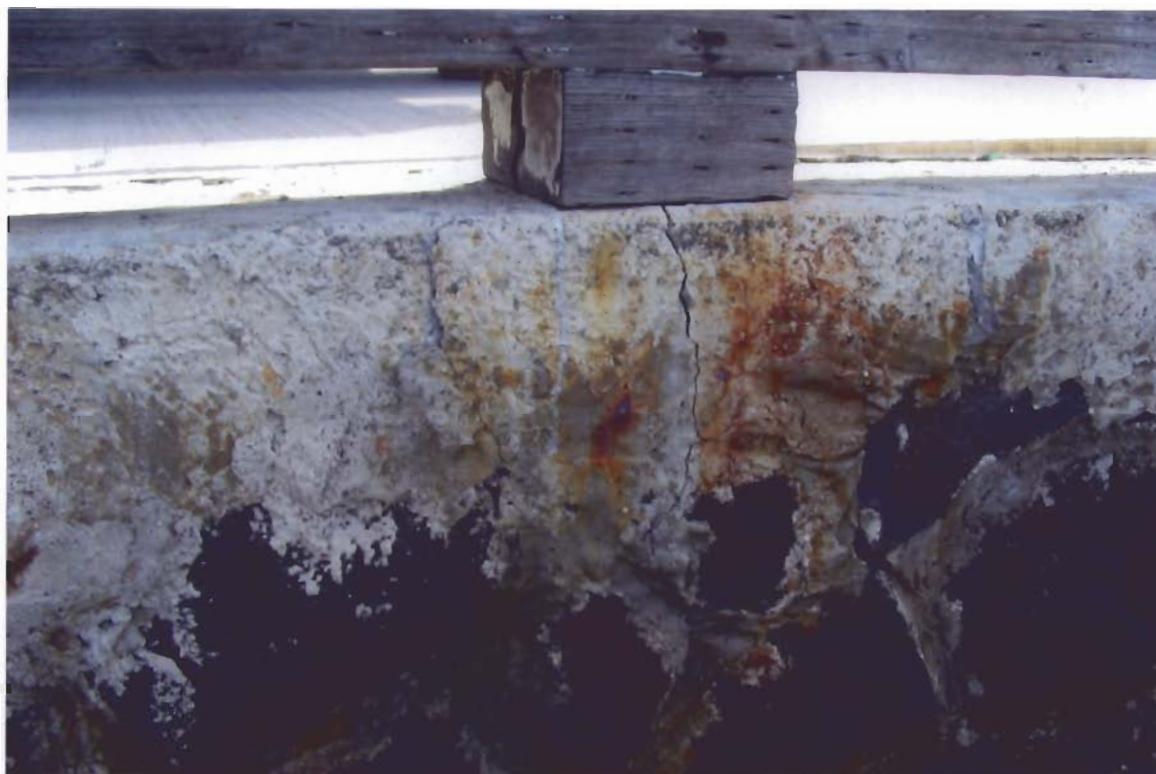
65

Crack CRM walls throughout
along Loading Dock No. 4

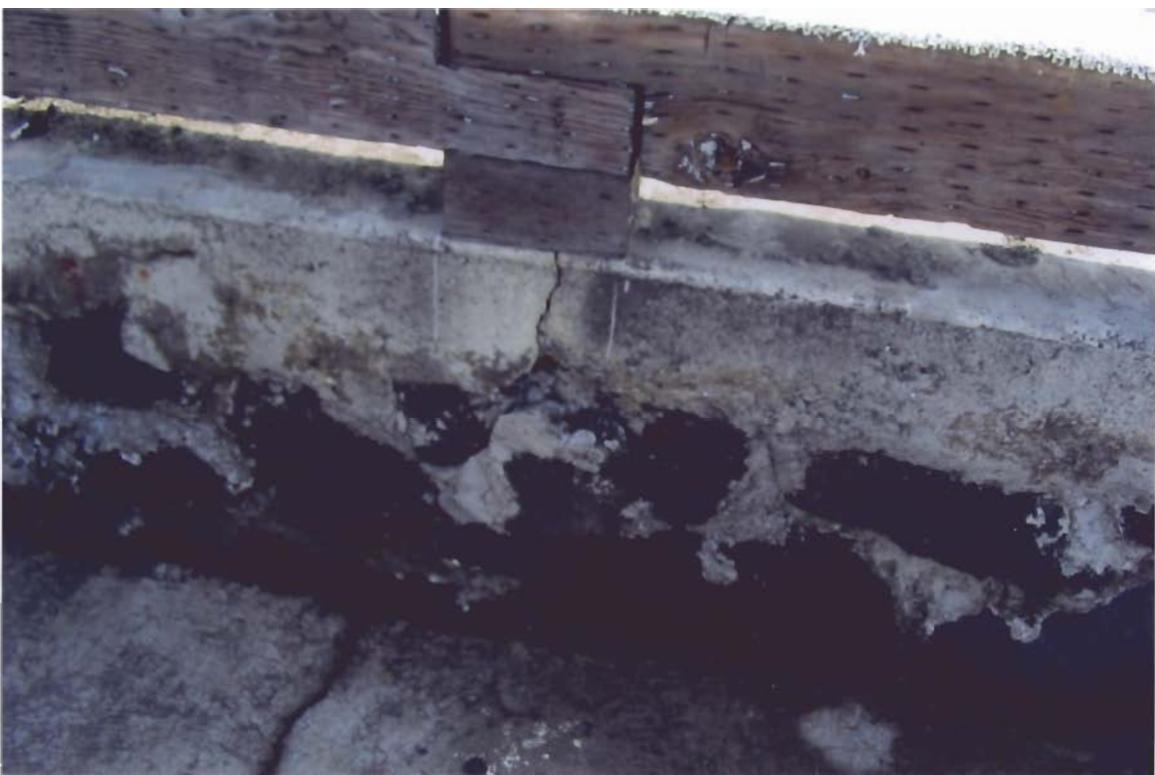
67

Crack CRM walls throughout
along Loading Dock No. 4

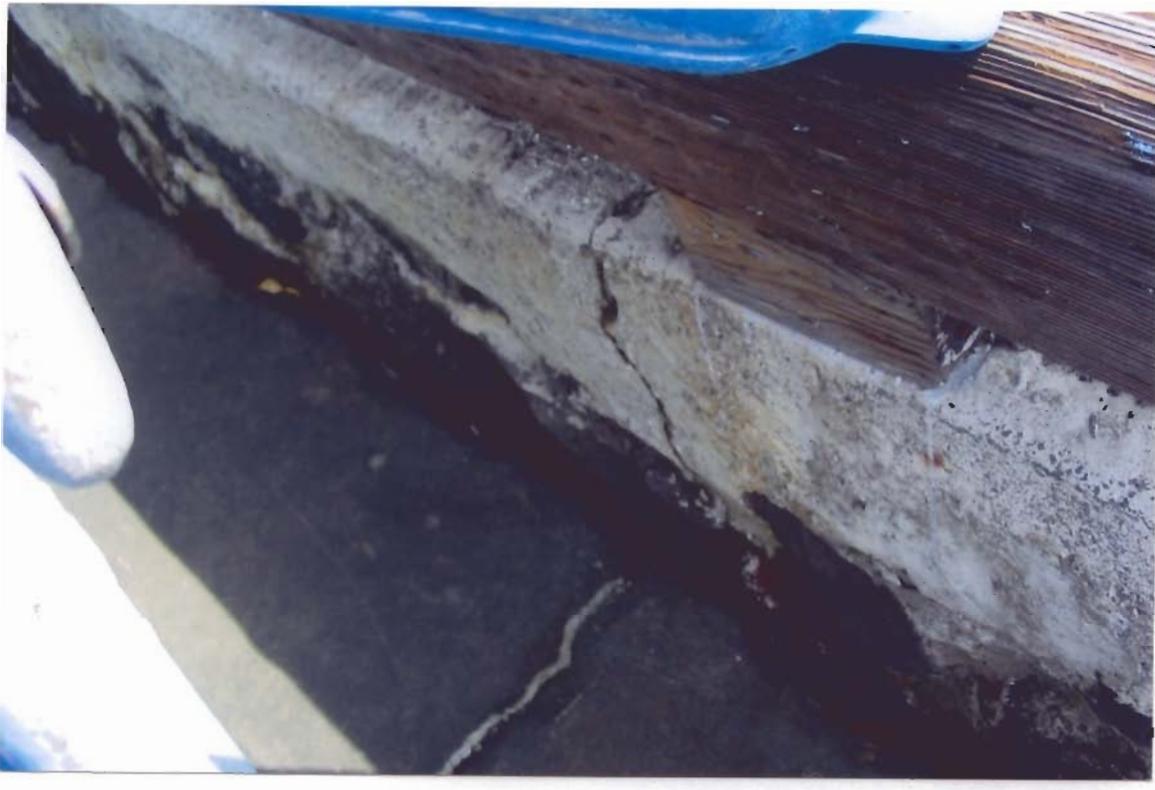
68

Crack CRM walls throughout
along Loading Dock No. 4

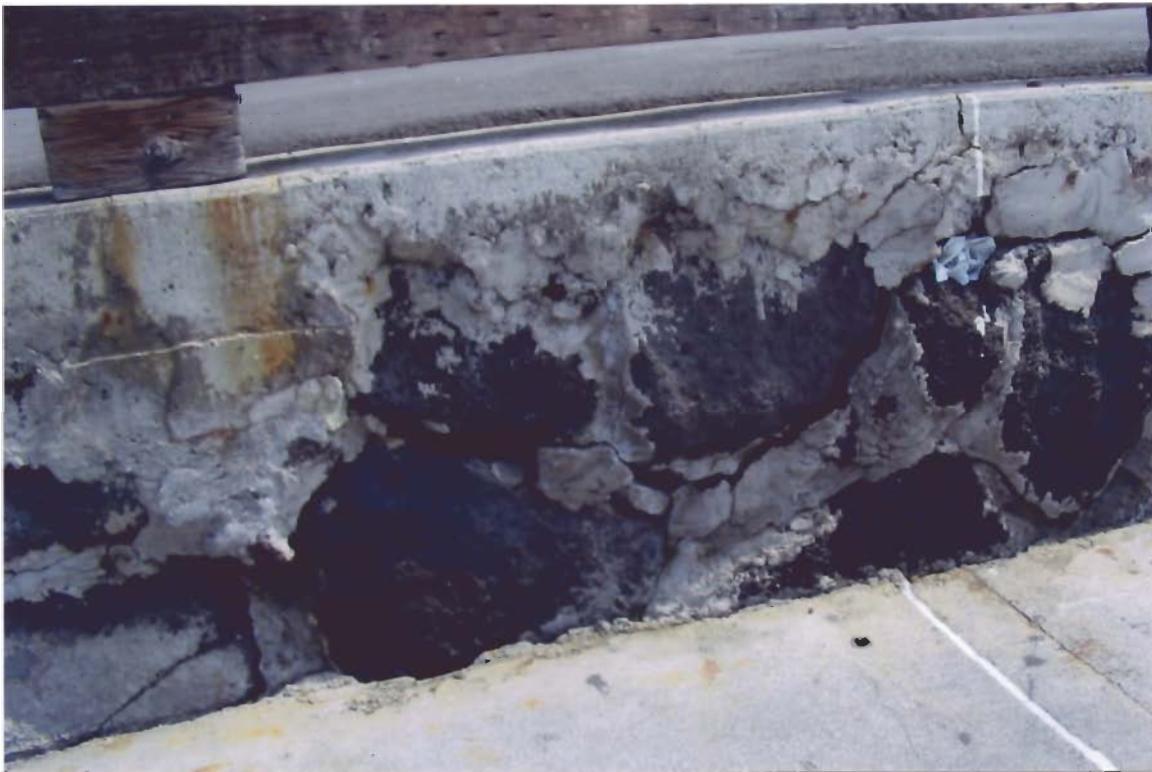
69

Crack CRM walls throughout
along Loading Dock No. 4

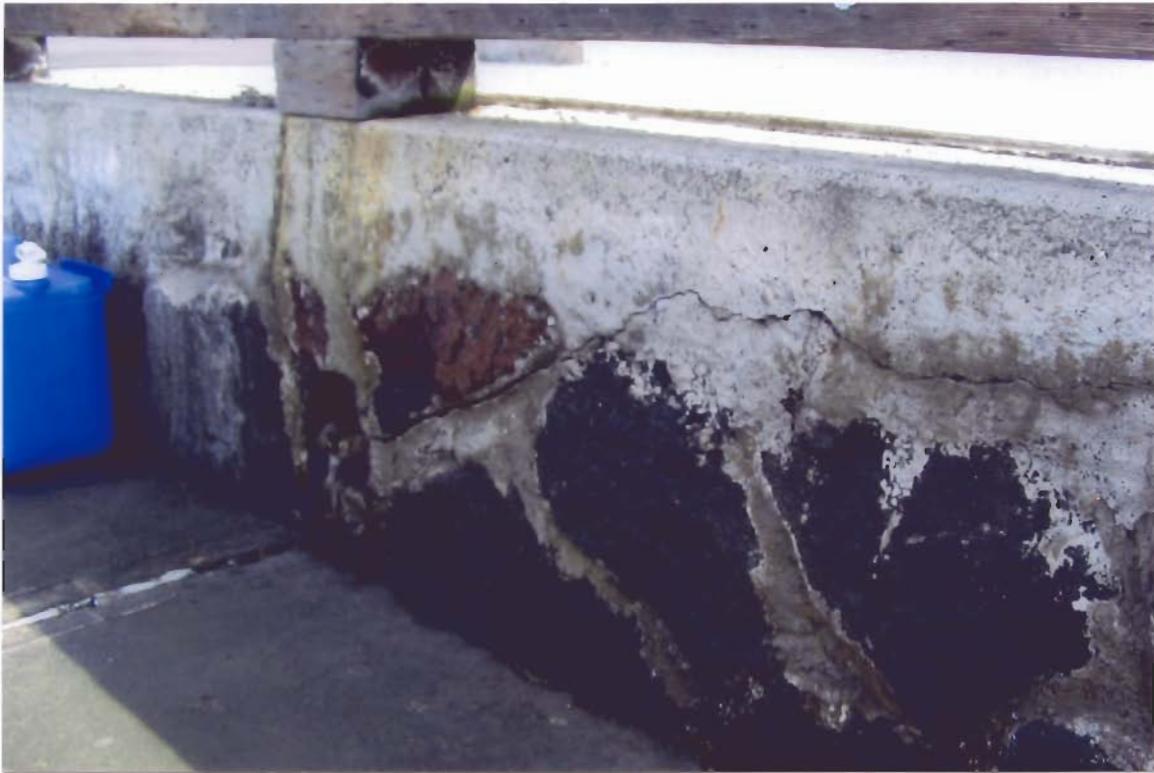
70

Crack CRM walls throughout
along Loading Dock No. 4

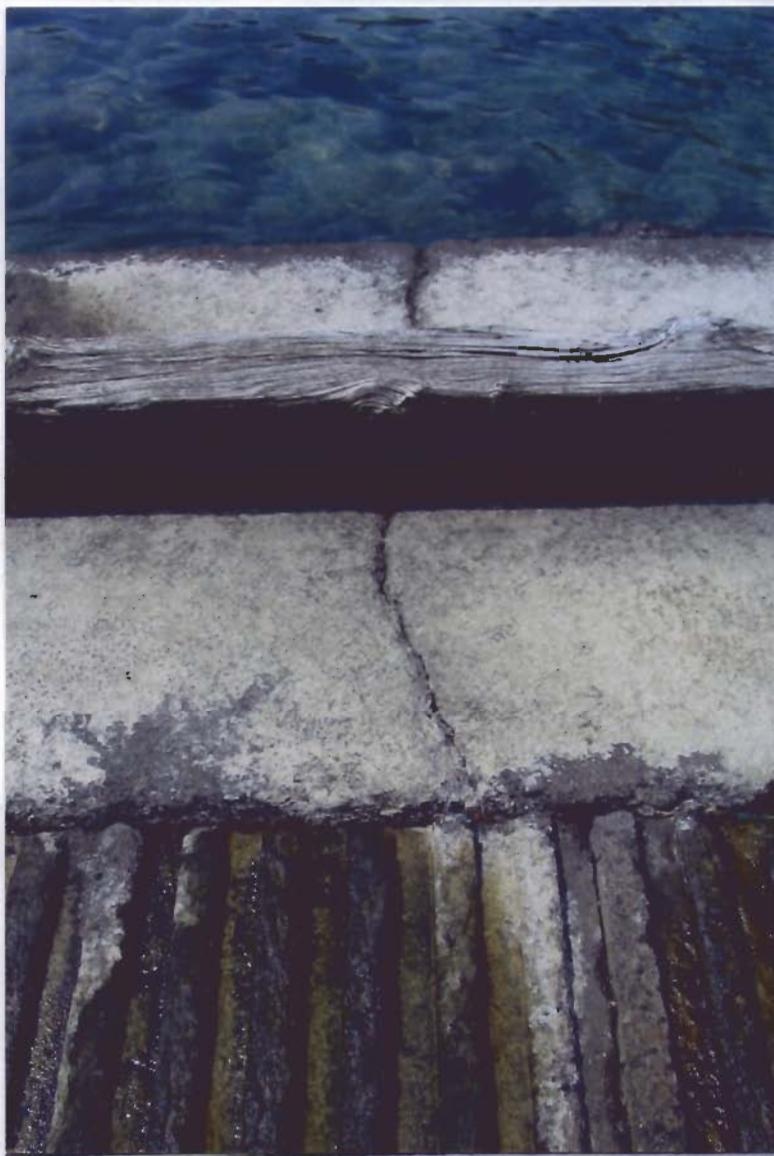
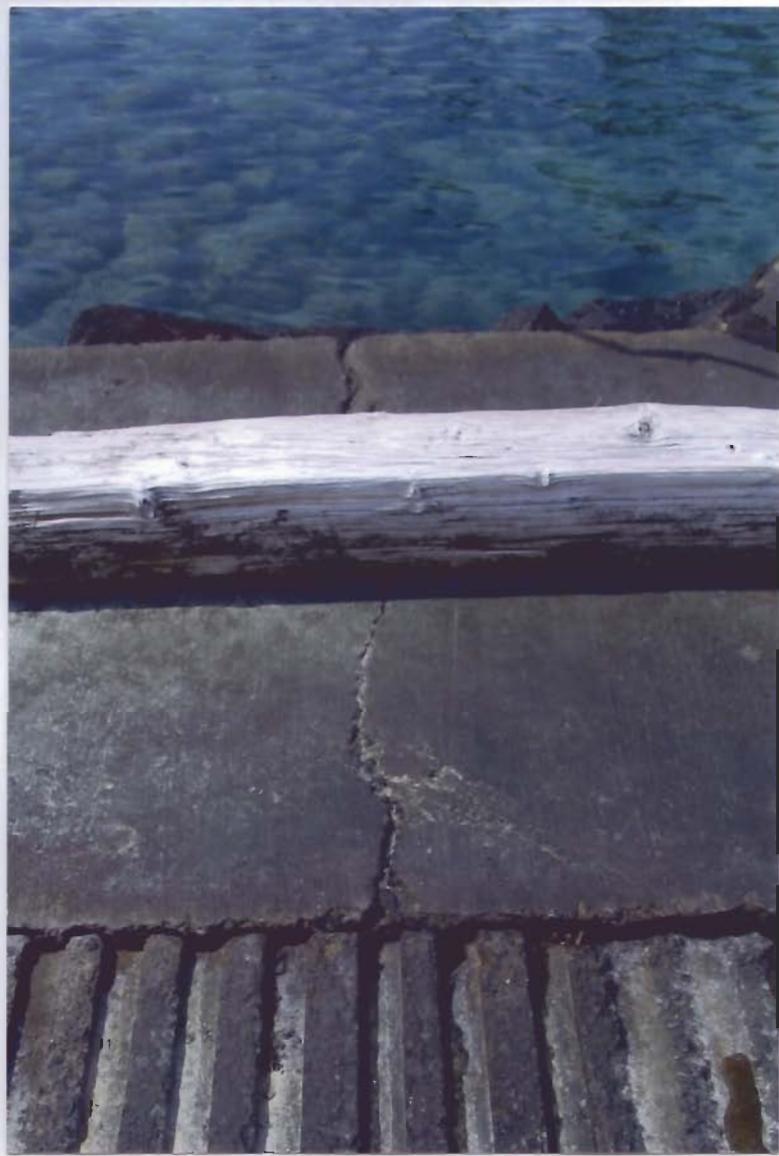
72

North West Side of Wharf -
Crack slabs at Boat Launching
Ramp

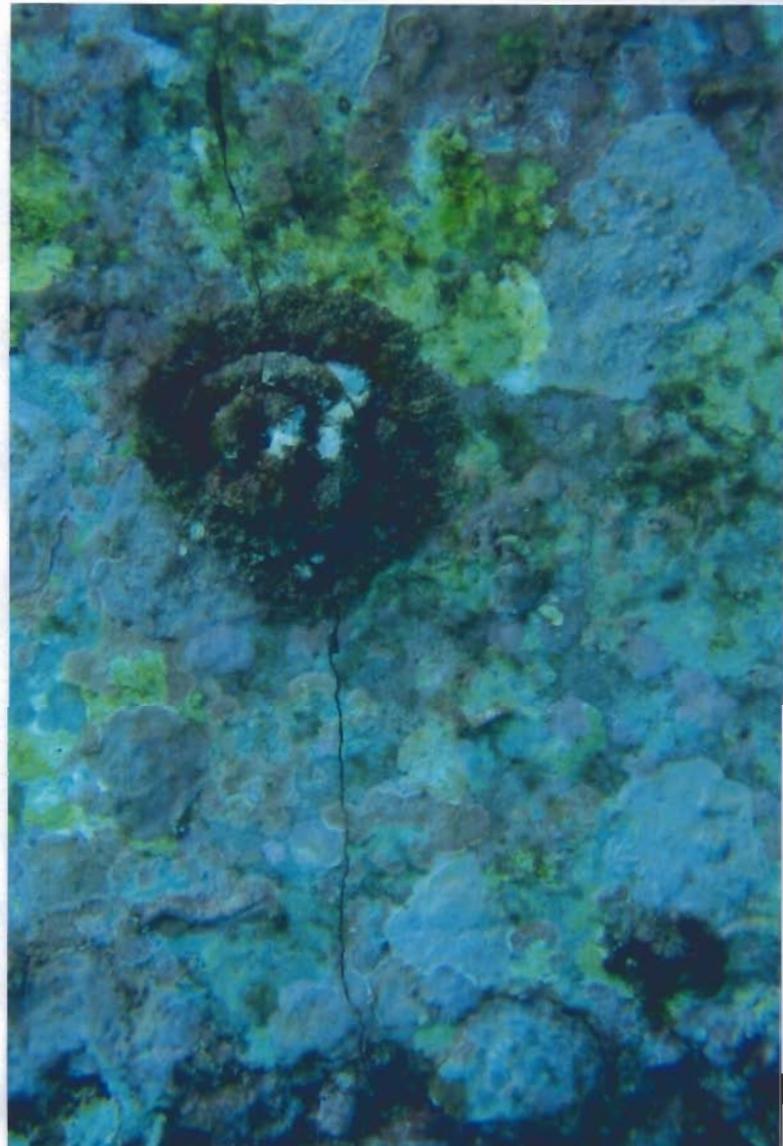
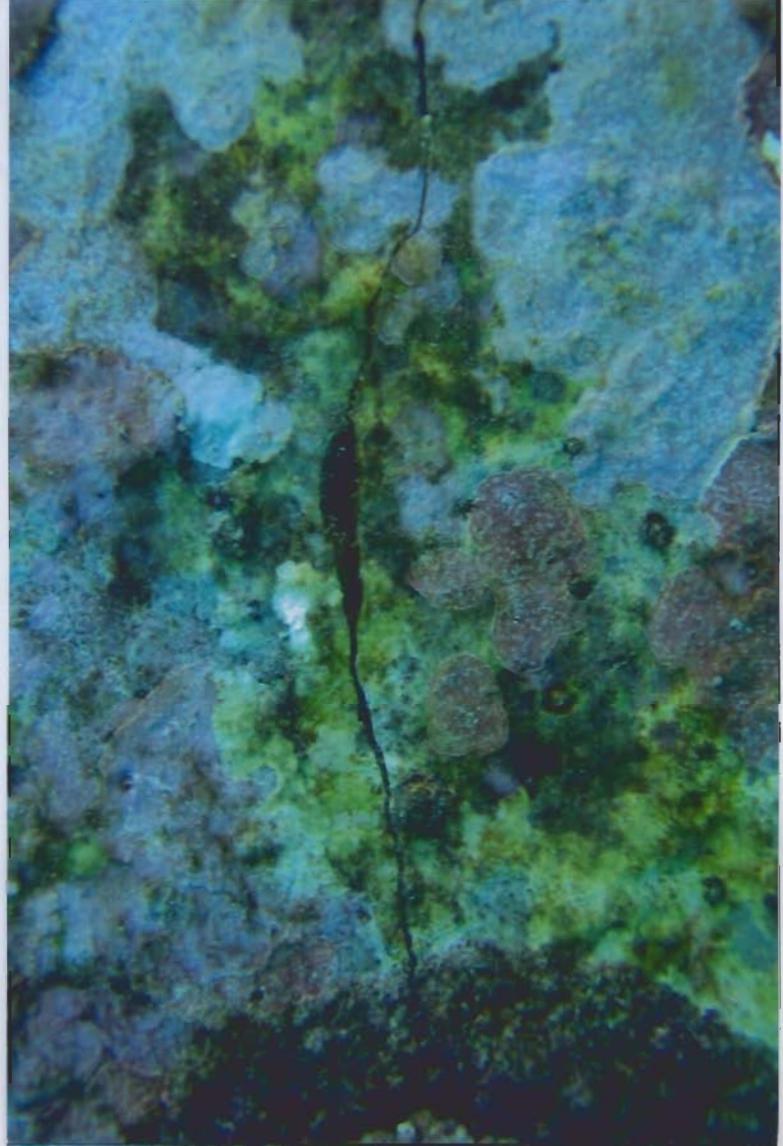
75

- B. Concrete Cap for Steel Sheet Pile Bulkhead - The concrete cap (2'-2" thick by 9'-6" deep) which protect the steel sheet pile bulkhead and reinforcing bars from the salt water have vertical cracks through the cap. The concrete cap are cracked along the length of the steel sheet pile bulkhead wall. The cracks run from the top of the cap to the bottom of the cap. The concrete cap supports and strengthens the top of the steel sheet pile bulkhead with a tie back system. The concrete cap also protects the steel sheet pile bulkhead and reinforcing bars from salt water corrosion. The cracks were caused by the recent earthquake on October 15, 2006.

Typical vertical cracks at sheet pile concrete caps.

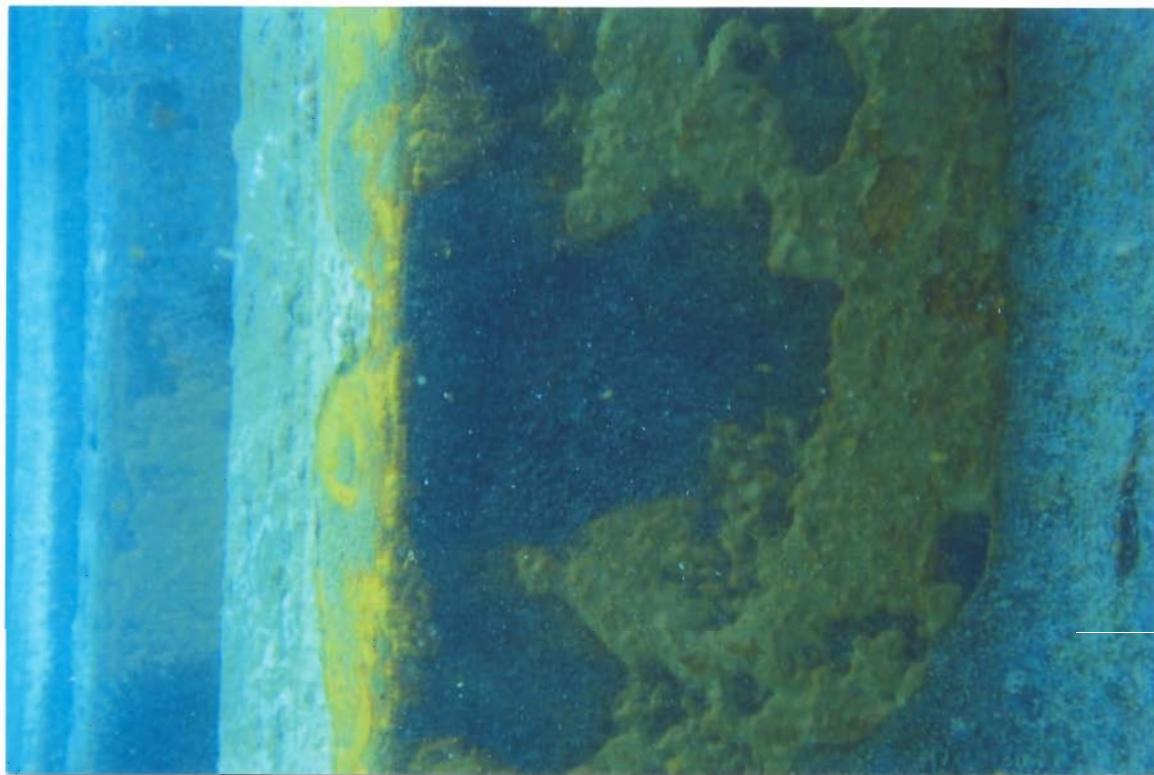
76

- A. Steel Sheet Pile for the Bulkhead - Steel sheet piles itself are in good condition. There are numerous areas of the steel sheet pile surface that the surface rust and marine growth had fallen off due to the bending and movement of the steel sheet pile from the earthquake.

Typical steel sheet pile - Area of rusted and marine growth surface layer dislodge and separated from the face of the sheet pile due to impact and bending of the sheet pile from the earthquake forces.

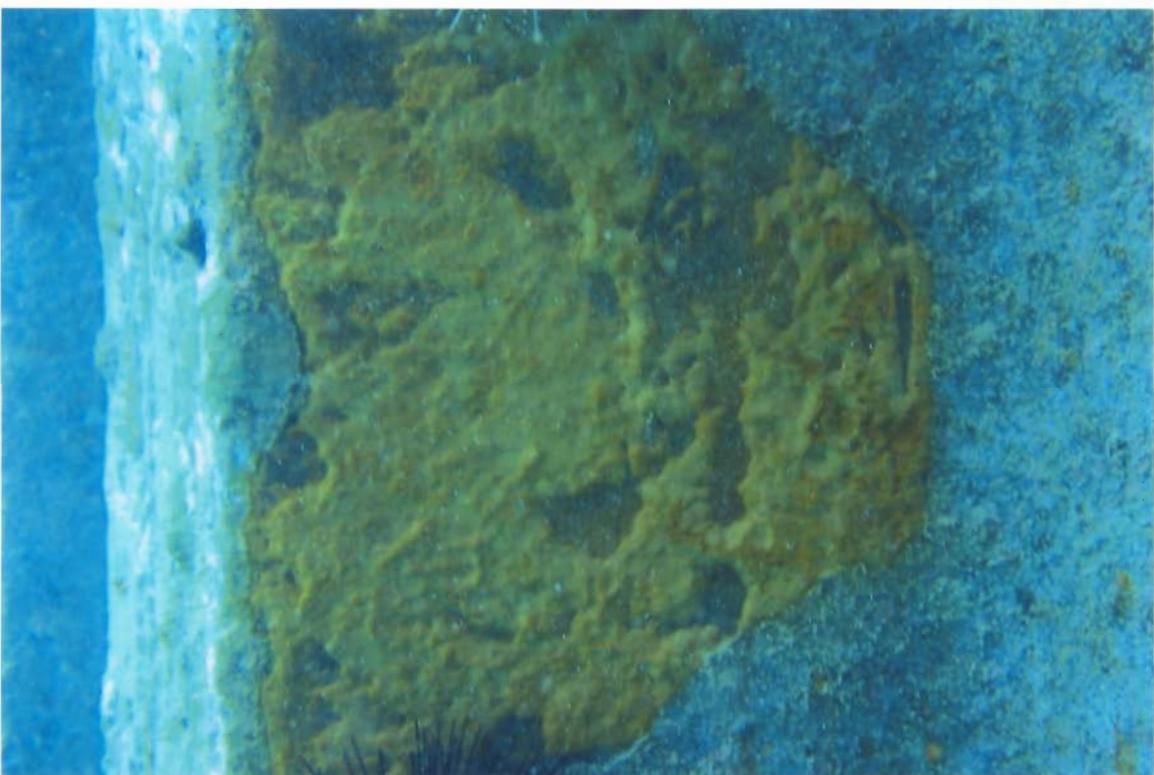
77

Steel sheet pile - Area where rusted surface dislodge and separated from the face of the sheet pile.

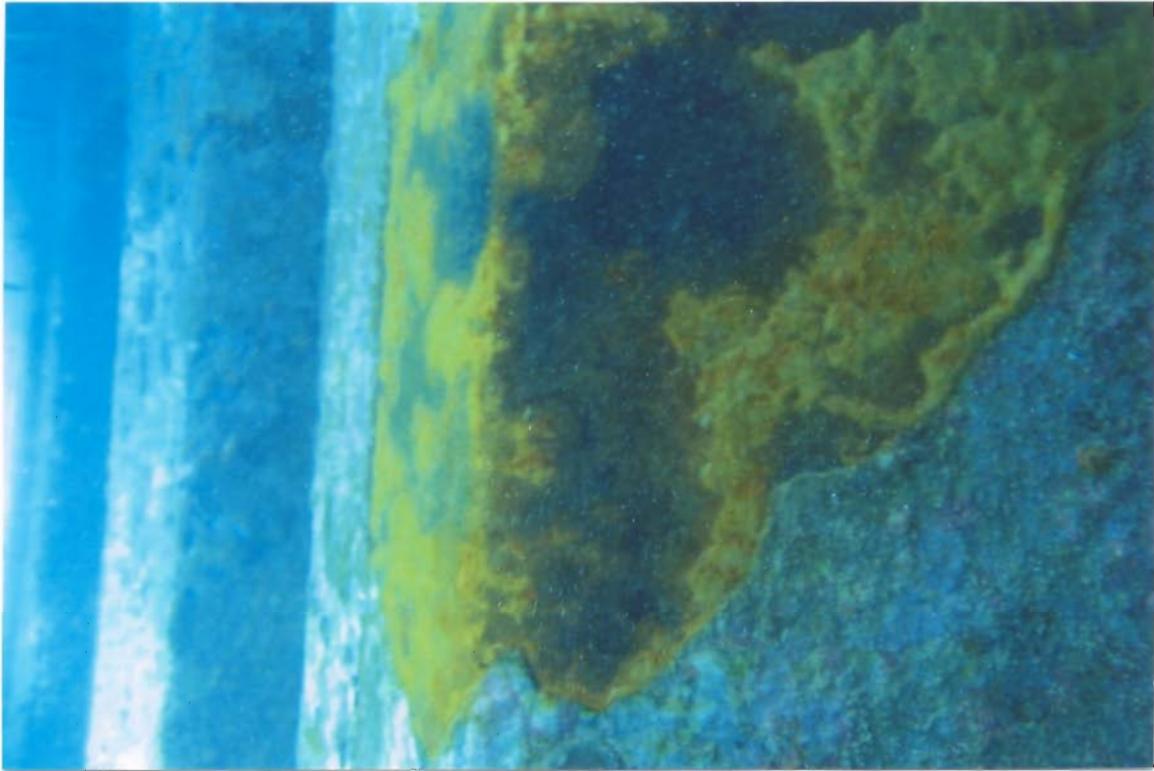
78

Steel sheet pile - Area where rusted surface dislodge
and separated from the face of the sheet pile.

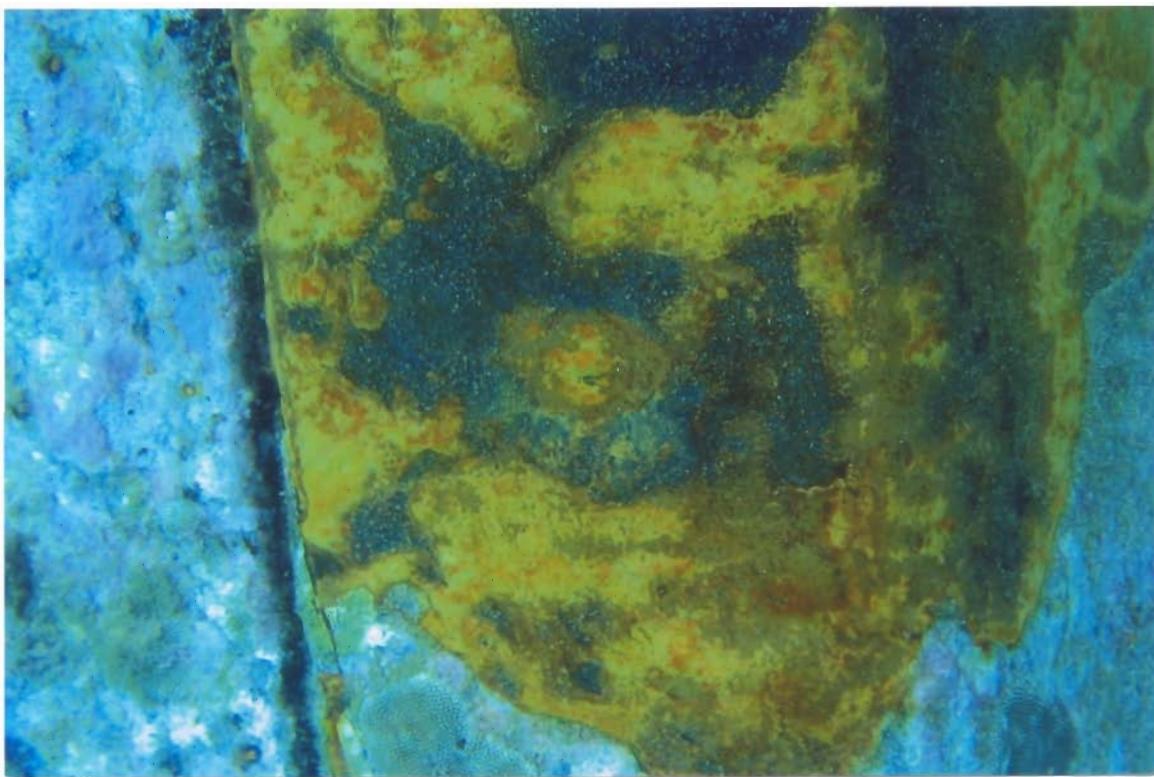
79

Steel sheet pile - Area where rusted surface dislodge
and separated from the face of the sheet pile.
